TITLE OF THESIS: A Technological History of Municipally Owned Public
Transportation in Edmonton, 1893-1981

DEGREE FOR WHICH THESIS WAS PRESENTED: Master of Education

YEAR THIS DEGREE GRANTED: 1985

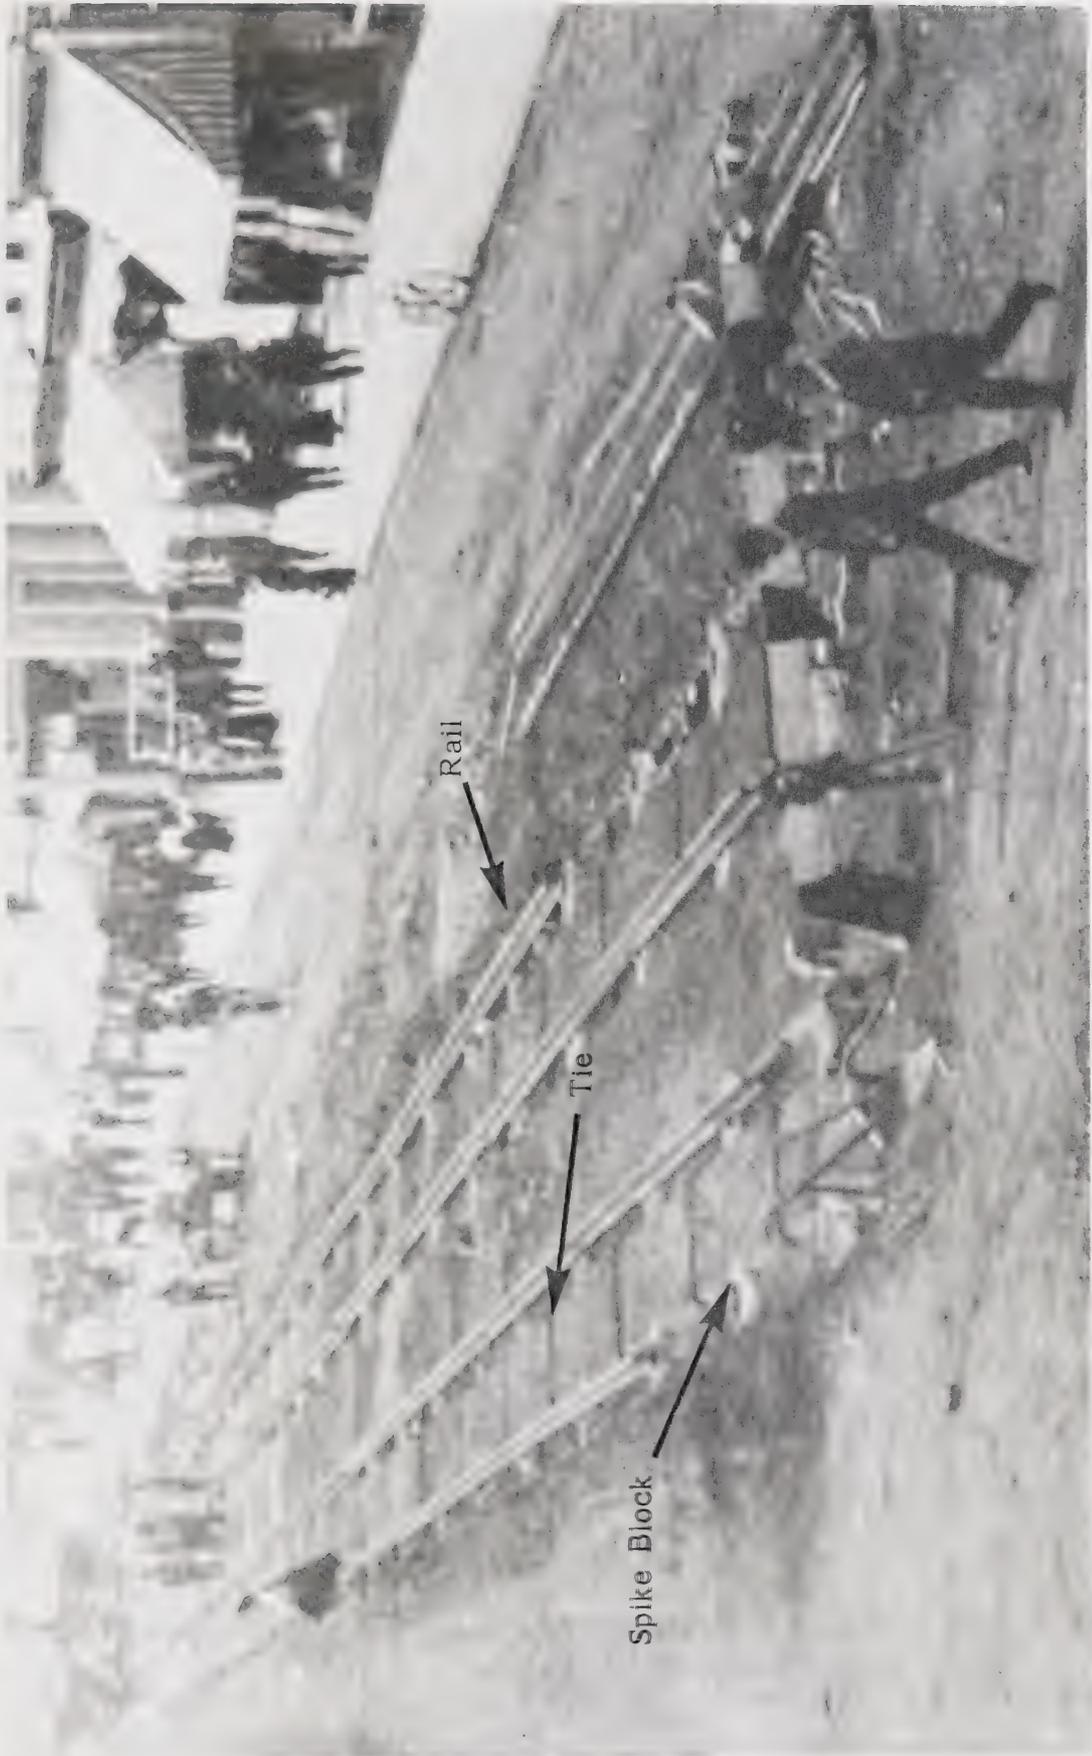
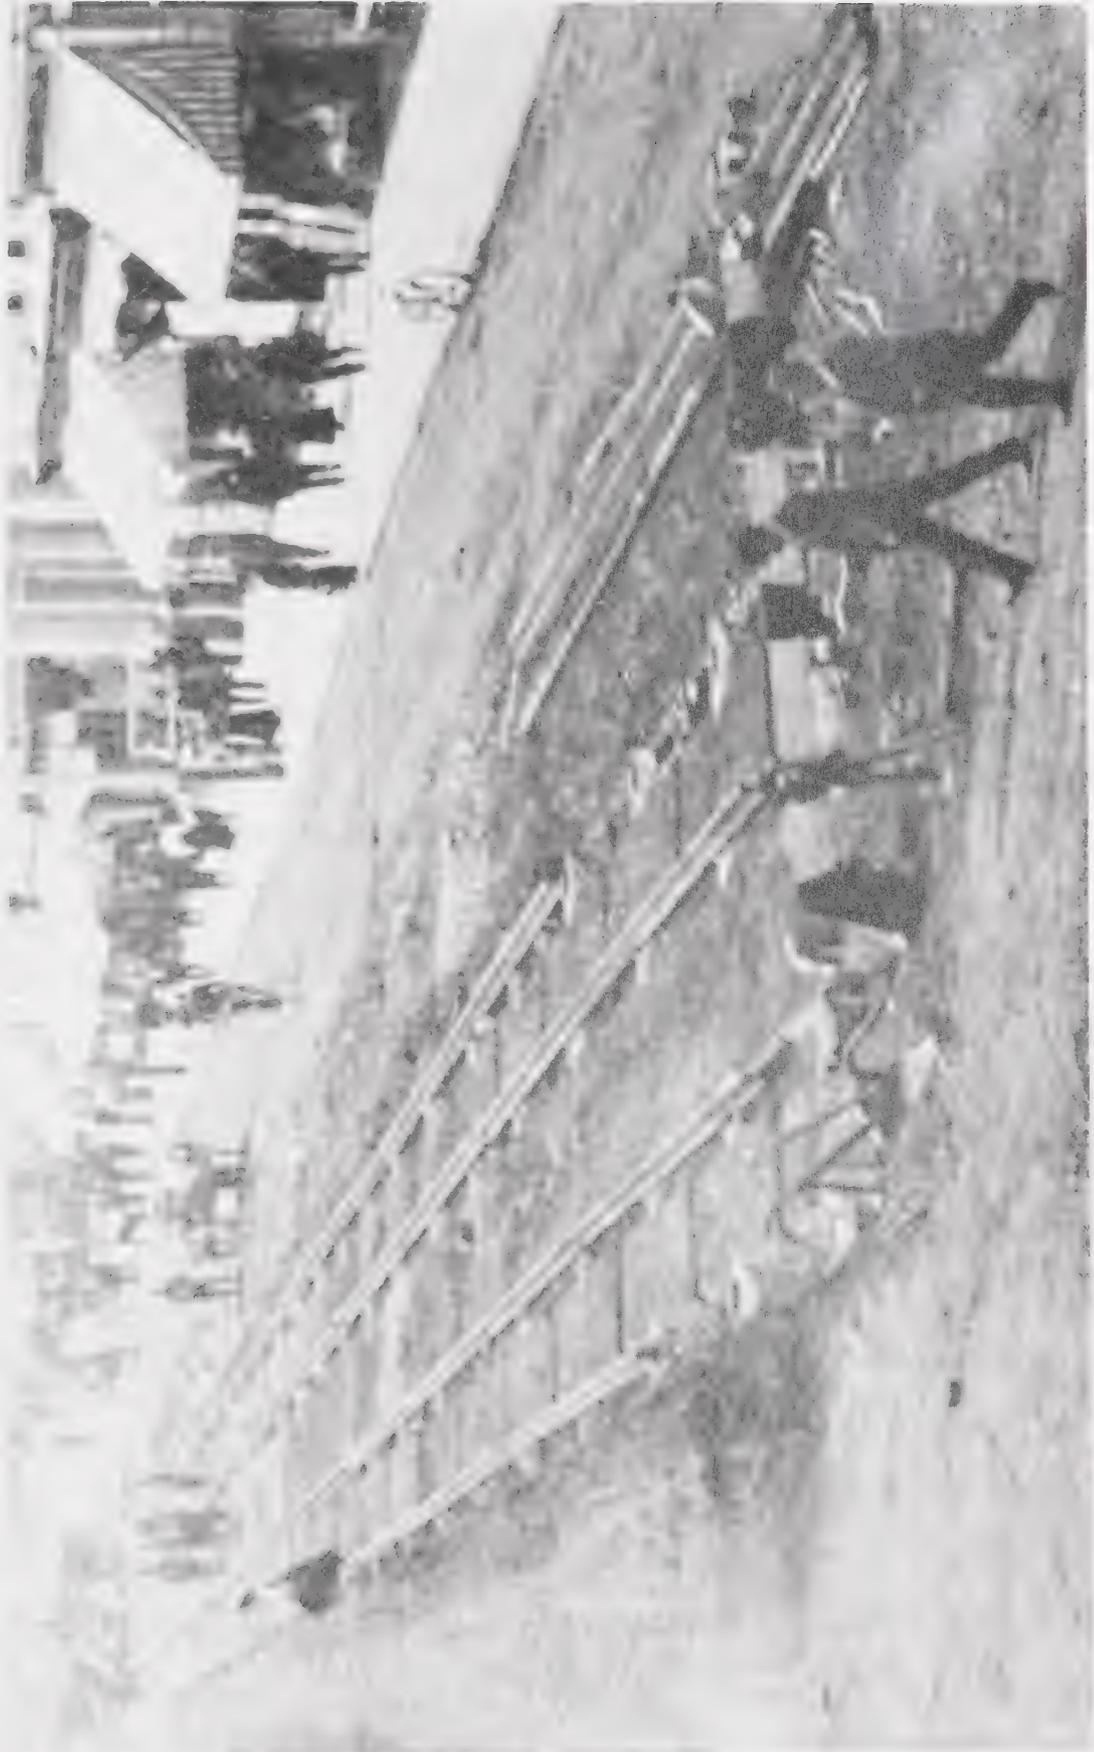
Plate 2. (City of Edmonton Archives) First Stages of Permanent Construction on Jasper Avenue, 1908

of Edmonton Archives) shows what the track construction looked like at this point. The spike blocks, steel ties and running rails are clearly visible in this plate and are labelled on the overlay.

8 inches (203mm) below the existing surface of Jasper Avenue. This sub-grade was not intended to bear the total weight of the rails. In order to support the rails further and in order to keep them at a pre-determined height, four rows of wooden spike blocks were set into the sub-base parallel to the sides of the trench. The rows of spike blocks were so placed that when the running rails were laid, the distance between the track centres would be 12 feet (3 658 mm). In each row of blocks, each block was placed so that it would lie directly beneath a running rail. Along each row, the individual spike blocks were spaced approximately 15 feet (4 572 mm) apart, and were held in place with concrete. (CEAR, pp. 51-52) The gauge, the distance measured between the facing sides of the rail heads, used for track laid on Edmonton's street railway was the standard 4 feet 8 1/2 inches (1 435 mm). To hold the running rails to this gauge, some sort of cross-tie had to be used. In the initial construction, steel ties were used. They were made from old 56 pound per yard (23.2 kg/m) T-rail that was cut into 6 foot (1 829 mm) lengths. (CEAR, p. 51) These "ties" were installed in an inverted position, perpendicular to the sides of the trench at intervals of 15 feet (4 572 mm). The ties were also placed so that they were midway between the spike blocks. Sections of running rails (Lorain 80-335), which were usually shipped in lengths between 30 and 33 feet (9 144-10 584 mm), were bolted together at the ends and were attached to the steel ties by clamps which were bolted in place. The running rails rested on the spike blocks previously set down in the sub-base. At this juncture, crews aligned the rails vertically using shims that were placed under the ties, and aligned the rails laterally by shifting the rails with pinch bars. After the rails were aligned, the crews attached the running rails to the spike blocks with ordinary railroad spikes. (CEAR, pp. 51-52) Plate 2 (City

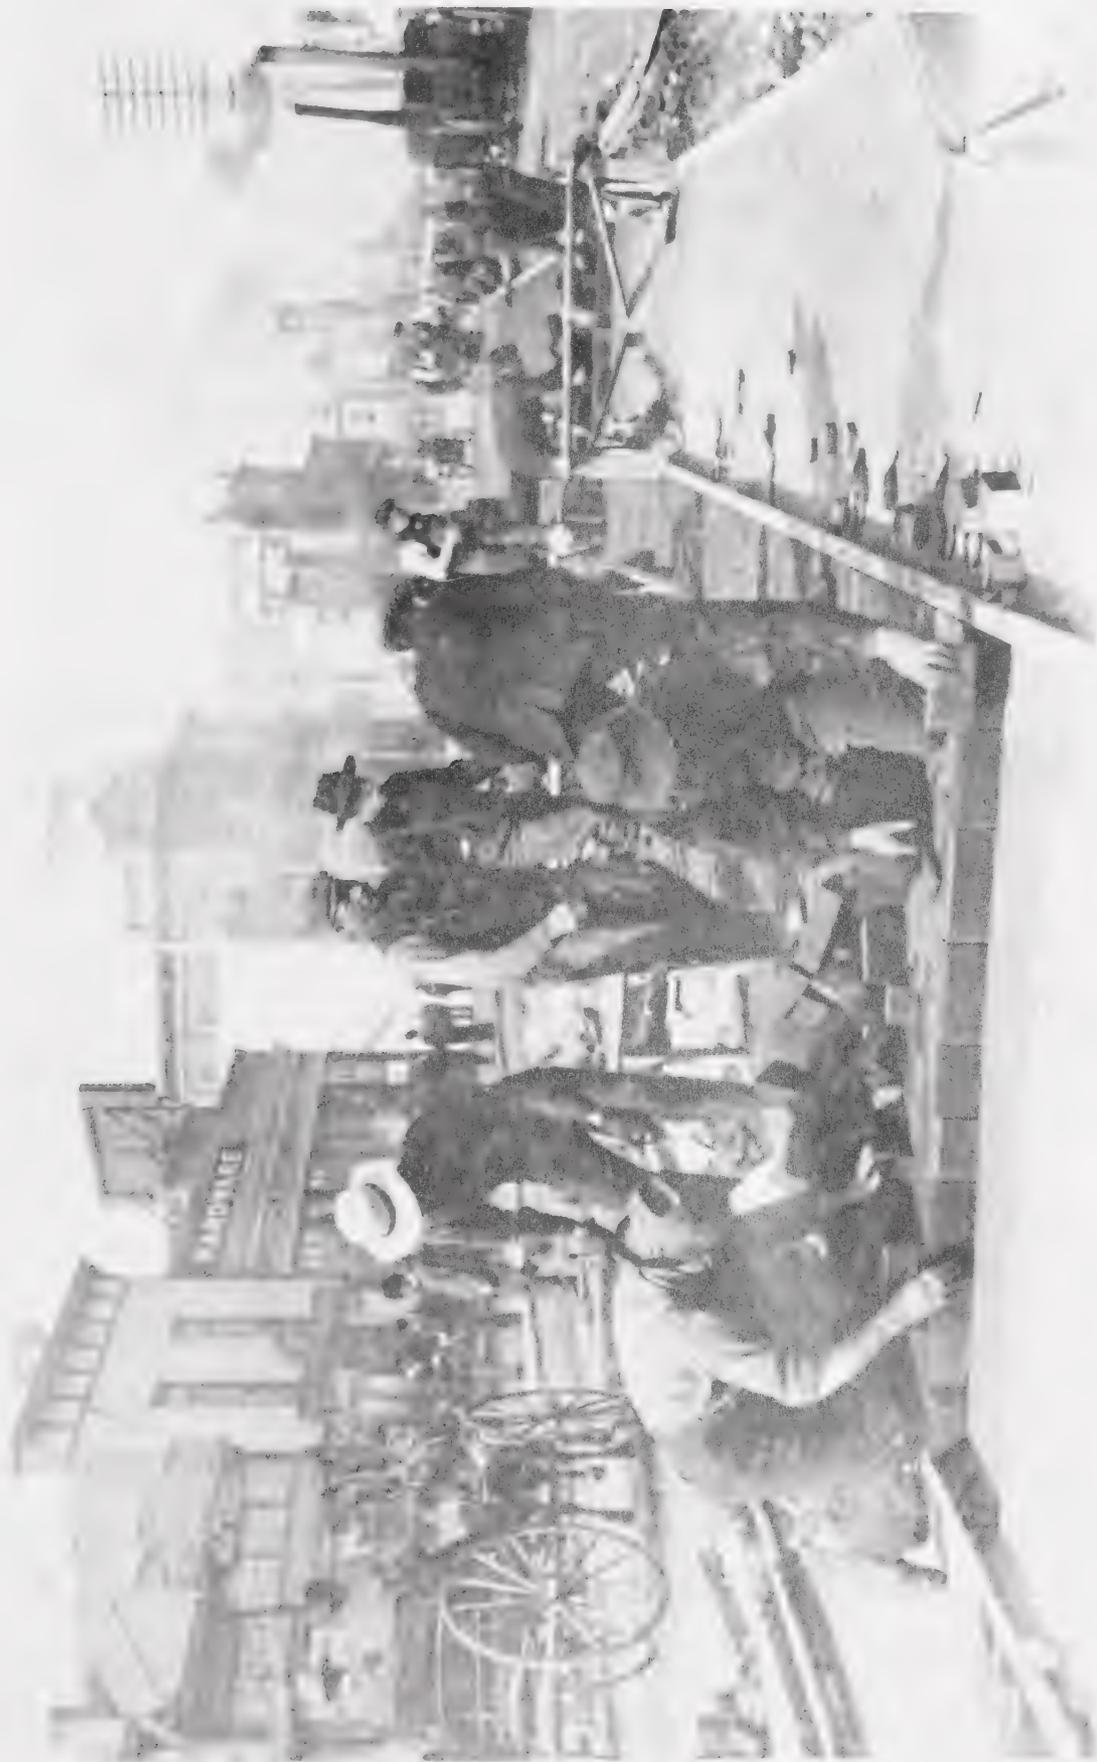
Plate 4. (City of Edmonton Archives) Crews Installing Wood Block Paving, 1908

designed to lie level with the tops of the running rails. Since most streetcars had flanged wheels, the edges of the blocks that were placed against sides of the rails where the flanges would pass had to be chamfered. If this was not done, the streetcar wheel would not remain on the head of the rail and the streetcar would probably leave the track. Once the paving was complete, the construction of the street railway track was considered finished. Figure 3 (based on descriptions in (CEAR, 1908, pp. 51-52, and Harding & Ewing, 1926, p. 285) shows a cross-section

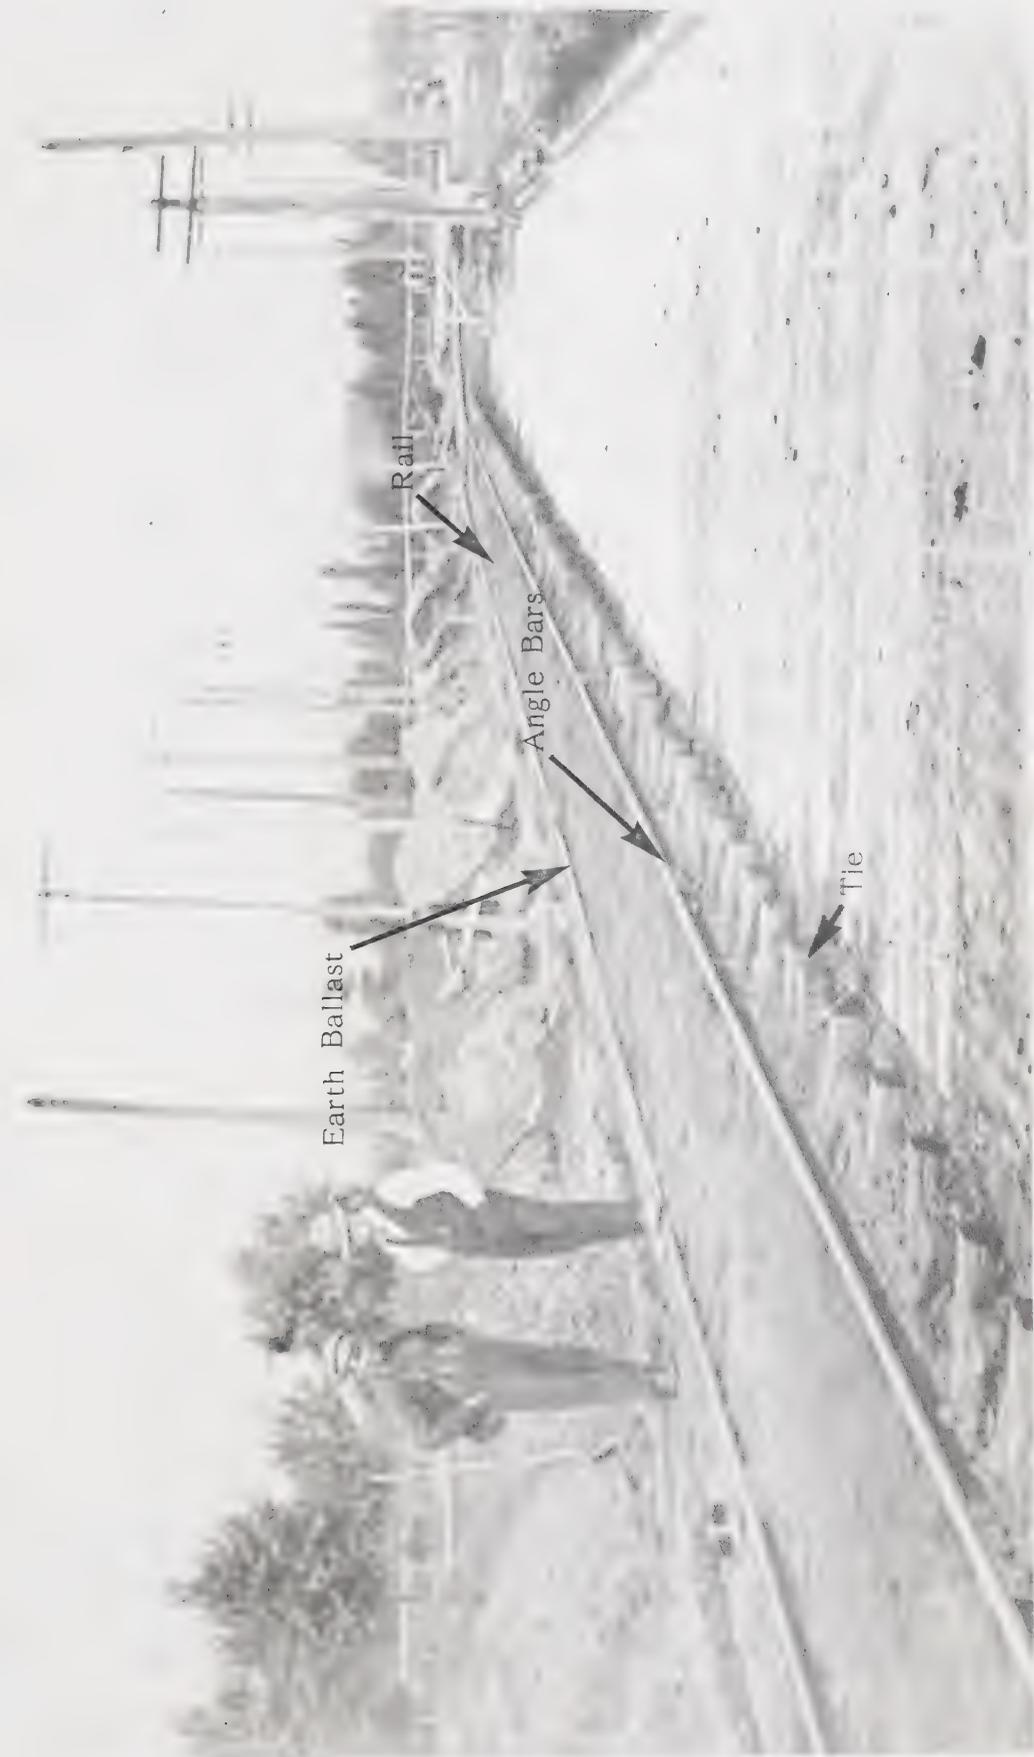
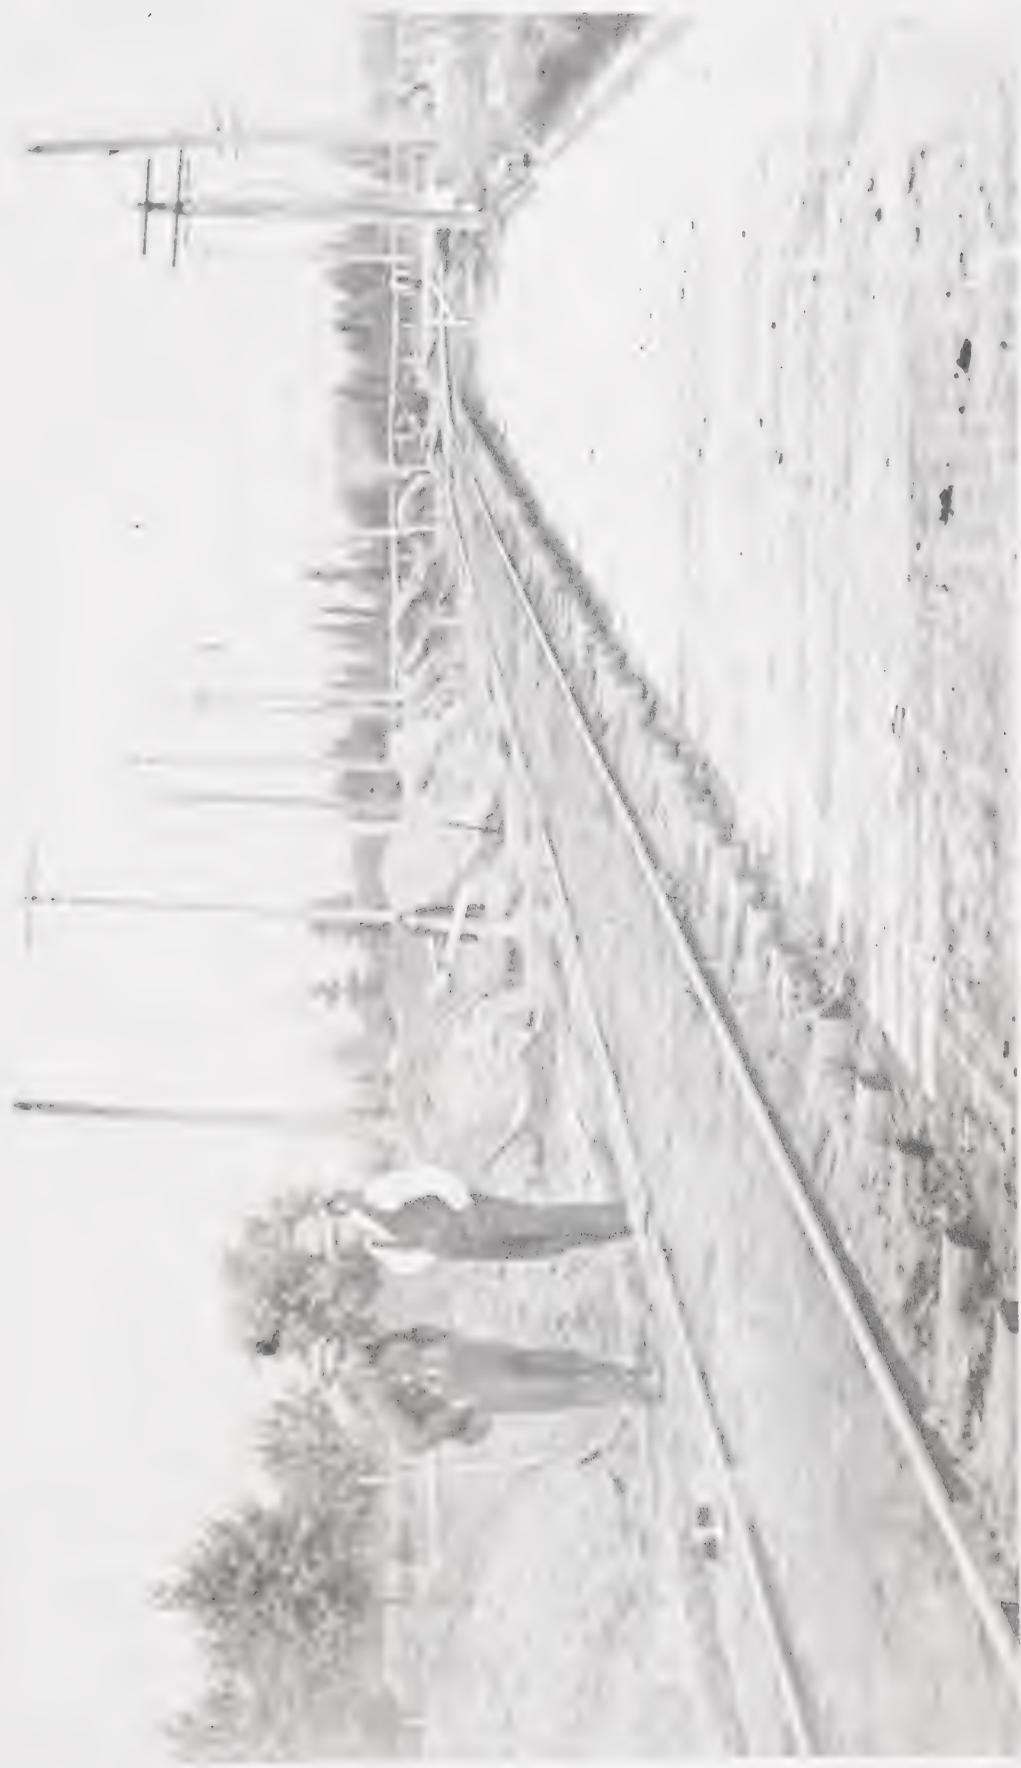
Plate 6. (Provincial Archives of Alberta) Temporary Track in Strathcona, 1908

W. A. Griesbach to "Public Service", October 16, 1907) While permanent track provided an ideal track, it was expensive and slow to construct. Temporary track, while not as substantial and esthetically pleasing as permanent track, was cheaper to construct and could be built faster. In addition, the City of Edmonton purchased the Strathcona Radial Tramway Company in August 1908 and agreed to construct an interurban line from Edmonton to various points in the City of Strathcona (see Chapter II for background of the Strathcona Radial Tramway Company). At this juncture, the street railway under construction in Edmonton and soon to be extended to Strathcona, became known variously as the Edmonton Radial Railway (ERR), or the City of Edmonton Street Railway Department. (City of Edmonton Bylaw 184, August 1908) A superintendent, Charles E. Taylor, was appointed at this time as well. Taylor had the authority to order equipment and supplies and to decide on what construction methods to be used, subject to the approval of the City Commissioners. (City of Edmonton Minutes of Council, Meeting 42, August 4, 1908)

There appears to have been two major factors in the decision to switch from permanent to temporary construction. One factor was financial considerations. As early as October 1907, it was known that the City of Edmonton was running short of money. (Letter from Mayor

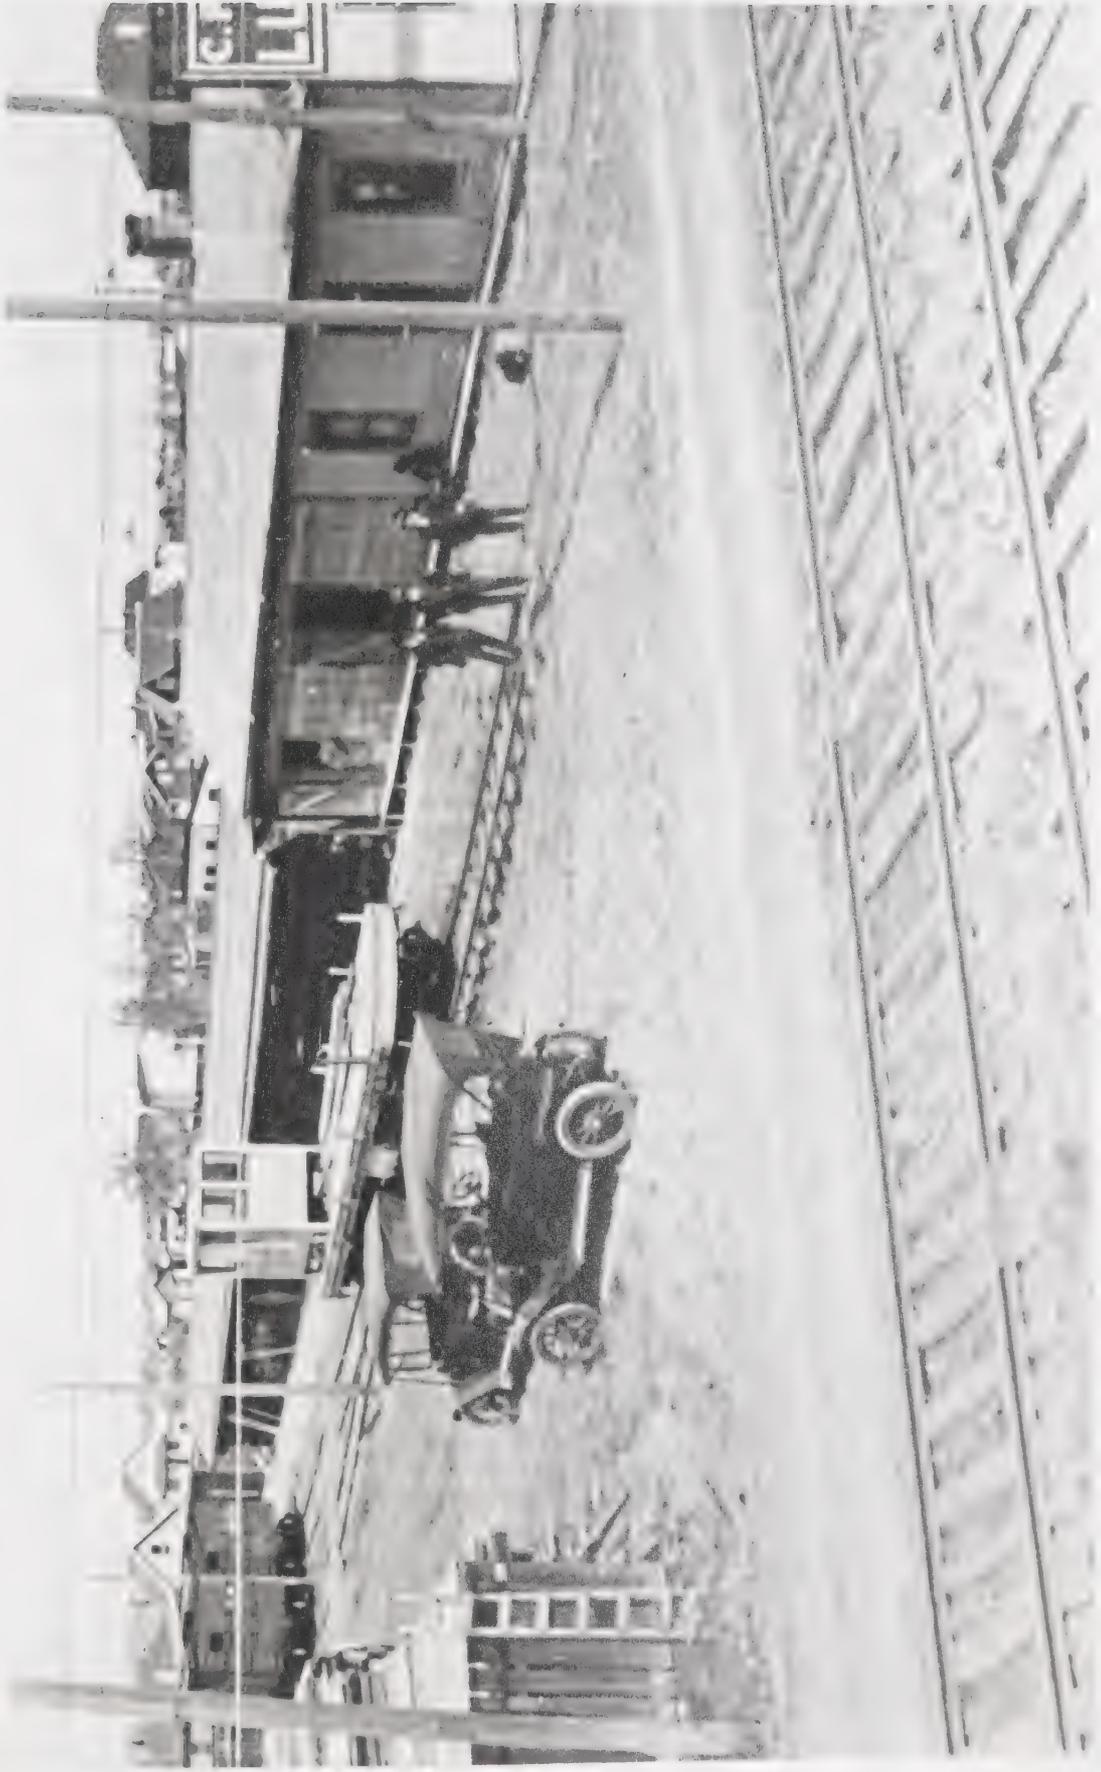
Plate 7. (Glenbow Archives) Taylor Spur and Work Car Number 4

In addition to the three freight spurs constructed, a special spur was built along Grace (62nd) Street from the Highlands passenger line on Knox (112th) Avenue, to a point immediately south of Alberta (118th) Avenue. The spur, which was 1,000 feet (304.8 m) long, was constructed for the sole purpose of transporting materials and supplies for the construction of the Edmonton Public School Board's new Highlands School, located

on the west side of Grace (62nd) Street, south of Alberta (118th) Avenue. (Edmonton Journal, November 14, 1917, p. 2, and Henderson's Edmonton City Directory, 1913) The construction of this spur emphasized the fact that the ERR had a vital part in the movement of freight within the City before the development of high capacity road vehicles. The spur was not used after the completion of the Highlands School. (Edmonton Journal, November 14, 1917, p. 2)

12). Side-bracket construction consisted of a series of single poles placed along one side of a single or double track. A steel tube (bracket) was then attached to the poles in similar manner as in centre-pole construction. Steel castings and a length of span wire was also attached to the tube (see Plate 7). (Doane & Parkham, 1926, § 18 pp. 15-18) Besides knowing what type of pole and suspension methods to use, installing crews had to know how far apart each pole (or poles, in the case of span-wire construction) was to be. In the initial construction, the standard distance between poles was 100 feet (30.5 m), except in areas of curves or special track work where the distance between poles ranged from 89 feet to 117 feet (27 m to 35.7 m). (ERR Drawing Showing Position of Poles, 1908) The distance between poles was considered sufficient to support the trolley wire adequately without excessive lateral movement of the trolley wire. Pole length ranged from 30 feet to 32 feet (9.1 m to 9.75 m). For each pole, a 6 foot (1.8 m) deep hole was bored into the ground with hand powered augers. (ERR Drawing Showing Position of Poles, 1908) Crews, using ropes, horses and long, thin spiked poles (sometimes called "pikes"), would raise each pole and place it in the hole. The steel poles were held in place with concrete while the wood poles were usually held in place with tamped earth. When the poles were in place, crews could then install the span wires and/or bracket assemblies. In the case of centre-pole or side-bracket construction, commercially manufactured bracket assemblies (tubes, castings and braces) were used. (ERR Drawing of Trolley Poles and Brackets for Proposed Edmonton-Strathcona [High Level] Bridge, November 1911) Where span-wire construction was used, 5/16 inch (8 mm) diameter stranded galvanized steel wire was attached to the poles so that the centre of the wire was 16 feet (4.9 m) above the centre of the road. When centre-pole or side-

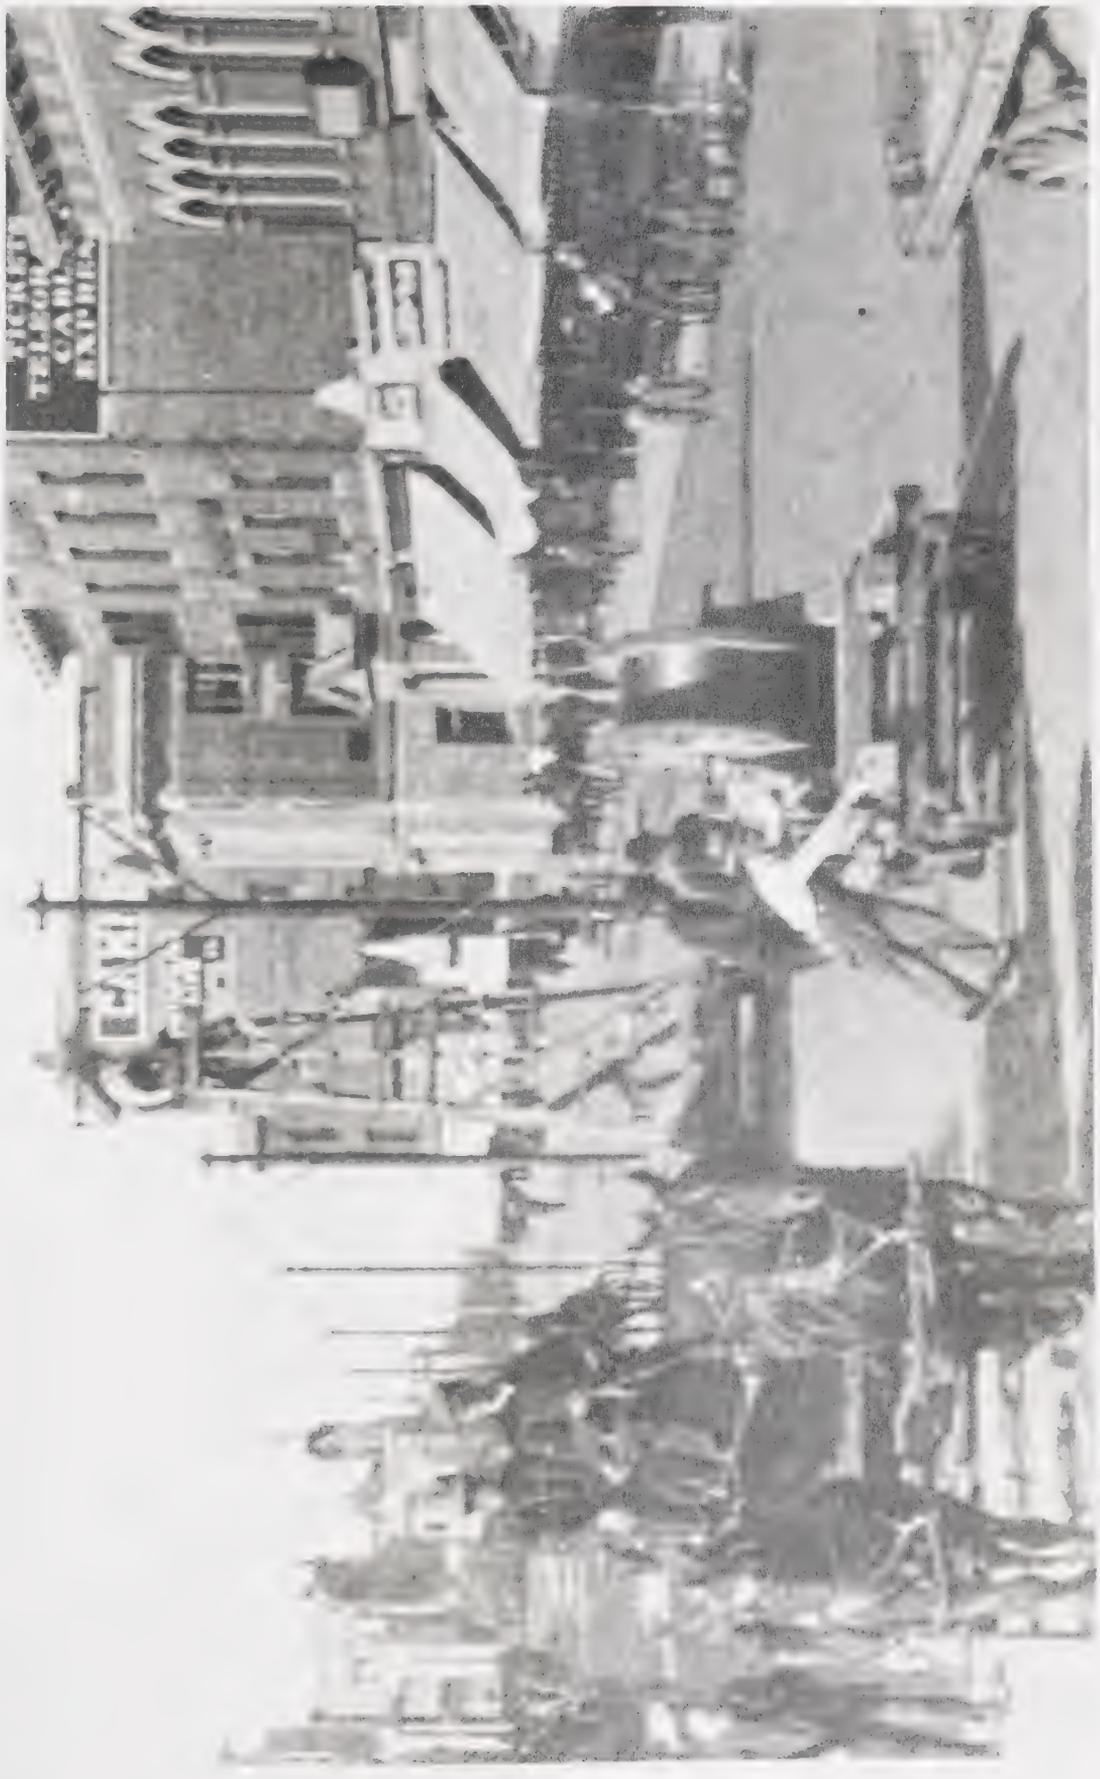
Plate 12. (City of Edmonton Archives) Installing Wire Above Jasper Avenue, 1908

In the initial construction, one end of a spool of trolley wire was attached to a pole at one end of the line. The spool, mounted on a push cart, was wheeled along the track. As the trolley wire unreeled, crews with the aid of a wooden tower temporarily fastened it to the span wires with short lengths of small wire. It should be noted that the trolley wire was "dead" (not connected to any power source) at this time. (Doane & Parkham, 1926, § 18, p. 18) Plate 12 (City of Edmonton Archives) shows a crew stringing wire along the south track on Jasper Avenue at 100th Street in the summer of 1908. The steel centre-pole construction, wooden tower, push carts and the spool of trolley wire should all be noted. The installation of the trolley wire was far from complete. In order to prevent an extreme electrical hazard and in order to minimize line loss, the trolley wire had to be insulated from the span wire. This was accomplished by the use of "hangers". Hangers were galvanized malleable iron castings that were designed to be attached to the span wire. The middle of the hanger casting contained a stud (threaded rod) or a bolt that projected a short distance from the bottom of the casting. The remainder of the stud was surrounded by a rigid insulating material, usually porcelain. The stud and the insulation were held in place by a cap screwed onto the top of the casting. (Doane & Parkham, 1926, § 18 p. 23) The hanger stud was designed to hold an

ear that would subsequently be attached to the trolley wire. Trolley ears, which were briefly explained earlier in this section, were castings that were designed to be screwed onto hanger studs and were also designed to be attached to the trolley wire. Trolley ears were usually cast of phosphor bronze or brass because these alloys resisted corrosion and wear and were also much stronger than ordinary copper. (Doane & Parkham, 1926, § 18 p. 24) There were two basic types of ears used, the plain ear and the feeder ear. The plain ear simply held the trolley wire to the hanger. The feeder ear possessed a lug that enabled a copper cable attached to the feeder to be connected to the ear. In this manner, feeder voltage reached the trolley wire. (Doane & Parkham, 1926, § 18 pp. 24-25) After the ears were installed on the hangers, the trolley wire was tightened with winches so that it did not sag. The ears were attached to the trolley wire by clinching (bending) the edges of the ear into the grooves of the trolley wire. Clinching was facilitated by the use of hammers and specially shaped steel anvil blocks known as "clinch blocks" which enabled hammer blows to be transmitted from the clinch block to the edges of the ear without damage occurring to the softer trolley wire. (Ohio Brass Catalog No. 23, 1940, p. 108) Figure 22 (after Doane & Parkham, 1926, § 18 pp. 23-25, and Ohio Brass Catalog No. 23, 1940) shows the typical appearance of a completed hanger, ear and 2/0 grooved trolley wire installation. The hanger depicted is a representation of an Ohio Brass Company type D straight line hanger. Although other brands of overhead materials were used, the products of the Ohio Brass Company of Mansfield, Ohio were most frequently used. (Letter from Canadian General Electric Co., Canadian importer of Ohio Brass products, to C. E. Taylor, ERR Superintendent, September 8, 1909, and artifacts in the author's collection)

frequently struck by the passing streetcar trolley wheels (current collector). Over a prolonged period, the ears would be destroyed by this action, necessitating costly repairs to the overhead assembly. Grooved trolley wire, however, offered a completely smooth surface for the trolley wheels. (Doane & Parkham, 1926, § 18 p. 14) Before the trolley wire could be installed, segmented tubular steel poles or wood poles had to be placed along the route of the streetcar tracks at regular intervals. In addition, the poles had to provide some sort of support that was arranged perpendicular to the track in order that the trolley wire would be held in the correct position at the right height. The type of poles to be used and their placement was the first step in the construction of the street railway overhead. Edmonton used both segmented tubular steel poles as well as wood poles and employed three main types of trolley wire suspension: span-wire construction; centre-pole construction; and side-bracket construction. Span-wire construction consisted of a series of two poles placed at both sides of the road directly opposite each other. A braided steel wire called a "span wire" was strung across the road and was attached to each pole at a predetermined height above the surface of the road (see Plate 6). Centre-pole construction, which could be used only along straight sections of double-track, consisted of a series of single poles placed between the two tracks. Attached to these poles were steel tubes arranged so that they projected over each track and mounted on the poles (at a specified height above the tracks) so that they were parallel to the ground. The tubes were supported by truss rods and tubular angle braces. Each of these tubes had two steel castings attached to it. One casting was affixed to the end of the tube while the other was attached several inches (mm) away from the first casting. A short length of span wire was then attached to each casting (see Plate

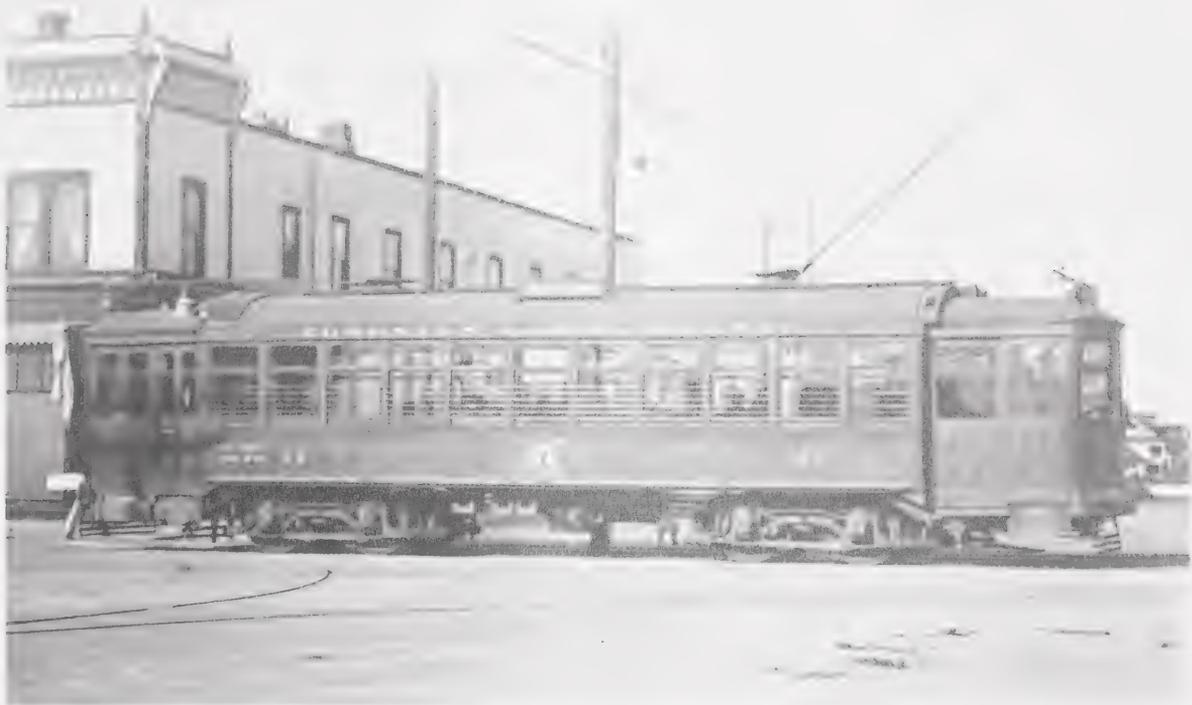
Plate 26. (Provincial Archives of Alberta) Streetcar Number 44 in 1913

Plate 26 (Provincial Archives of Alberta) shows the appearance of street-car Number 44 at some time during 1913. The following should be noted: marker lamps at both ends, illuminated signs, running boards, folding steps, fixed step, and the smoke stack. It should also be noted that the message "Have Exact Fare Ready" was added in 1913.

Illuminated signs, manufactured by the Hunter Company, were installed on both hoods of each streetcar as well as on the roof in the middle of each side. Each sign contained one incandescent bulb for illumination, in addition to a length of silkscreened canvas that was moved by an arrangement of geared rollers. Two marker lamps, manufactured by Peter Gray and Son, were placed at both ends of each streetcar on either side of the illuminated sign. Each marker lamp held four lenses. Their colors were: red, green, blue and clear. Each marker lamp was illuminated by a single incandescent bulb. All the bulbs on the streetcars, with the exception of the headlights, were 16 candle power (20 W) incandescent bulbs. (St. Louis Car Co. Specifications, pp. 7-8) The marker lamps and the hood-mounted illuminated signs were protected from the trolley pole by a steel framework which also included a hook to hold down the trolley pole when it was not required. (Plate 26)

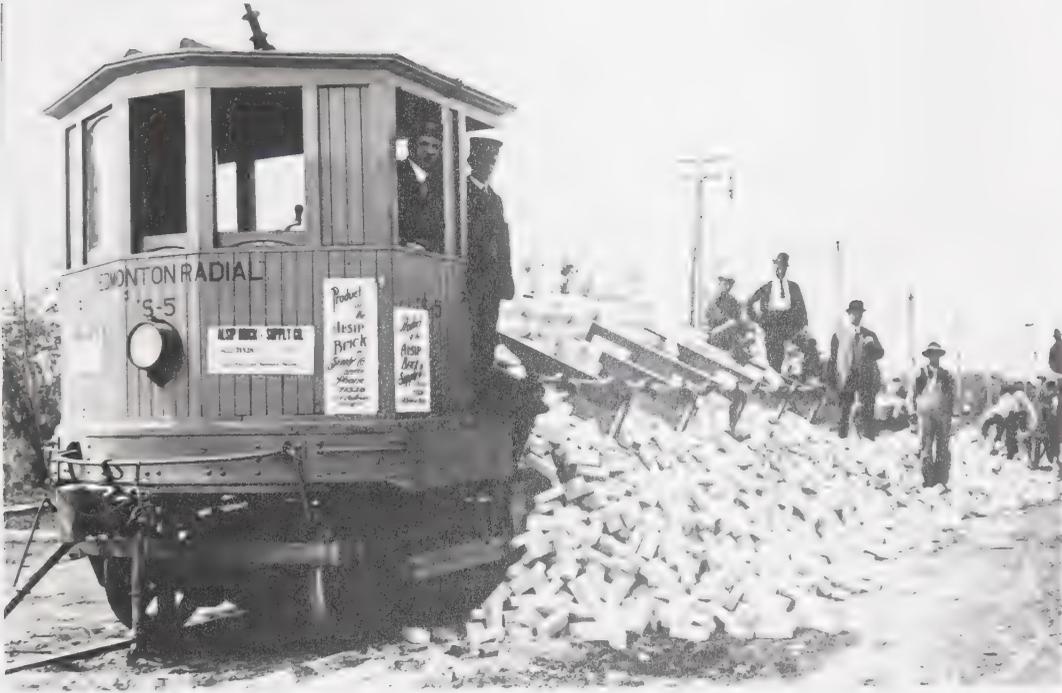
Plate 28. (Glenbow Archives) Differential Dump Car S-5

This unusual item of rolling stock consisted of a narrow steel frame mounted on two trucks which supported a segmented steel bin which could be tipped towards either side of the frame, thus allowing the contents of the bin to spill onto the ground. (See Plate 28) This type of car was referred to as a differential dump car because the bin could tilt to either side. The segmented steel bin was attached along its centre to the dump car frame by a long hinge. A patented system of levers fabricated by the Simplex Company controlled the bin's position. The sides of the bin consisted of steel doors which were hinged along the

on the right hand rail. (See Plate 28) The dump car was painted, lettered and numbered before it was delivered to the ERR. The lettering consisted of the name "Edmonton Radial" placed on the front of the cab and the designation "S-5" placed on both sides and the front of the cab. Although the dump car was constructed as a single end unit, the trolley pole could be swivelled around. In this way, the dump car could travel backwards great distances. Plate 28 (Glenbow Archives) shows S-5 dumping a load of bricks near the site of the Highlands School during 1913 or 1914 after backing along the spur placed on Grace (62nd) Street. (See Chapter III and Map 7)

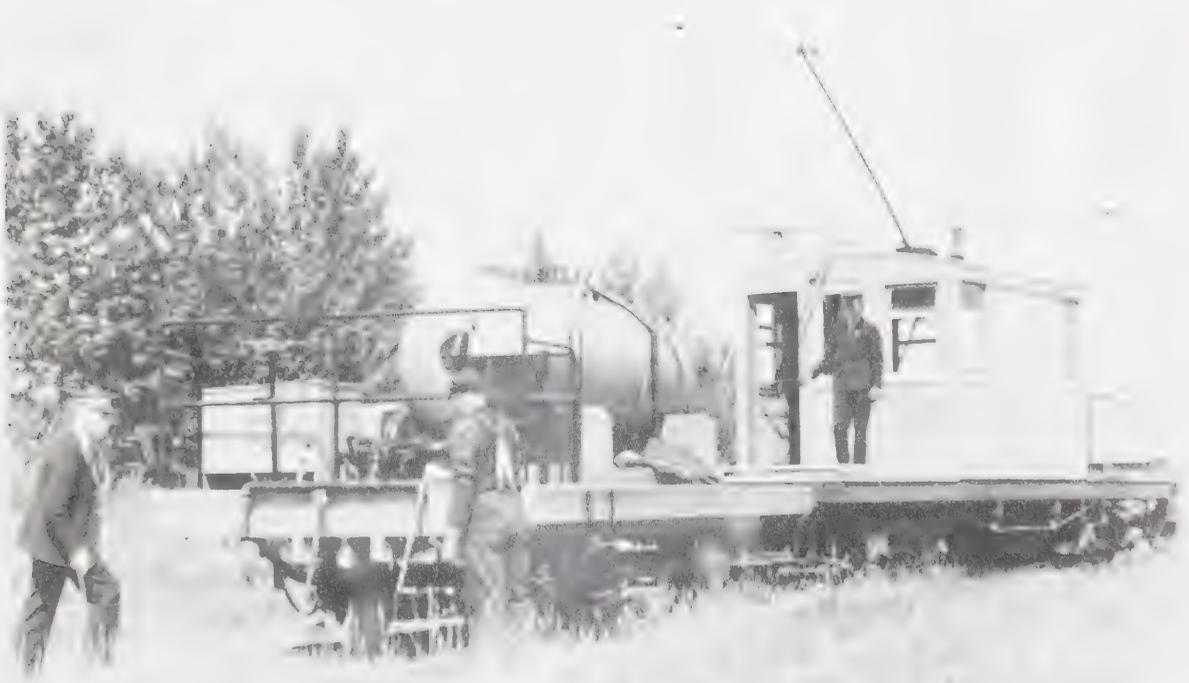
Plate 29. (City of Edmonton Archives) Sweeper Number 2 Pulling Weed Killer Car

The previous section mentioned that the frame and the trucks of streetcar Number 2 were used as part of a new sweeper car. This unit, which was completed by November, was a single end sweeper. The body frame, without the vestibules, supported a wooden deck and a cab which was placed in the centre of the frame. The cab contained a heater in addition to the controllers and the air brake valve. A broom assembly taken from the McGuire-Cummings sweeper was placed at one end of the frame. A truss assembly along the left-hand side of the cab near the roof supported the end of the broom assembly. A small wooden box placed in front of the cab enclosed the broom motor and protected it from the elements. (SRDMR, June-December 1918, and Plate 29) Plate 29 (City of Edmonton Archives) shows the ERR built sweeper sometime during the early 1930's. The truss rod leading from the cab roof should be noted. The small vehicle behind the sweeper is former passenger car Number 7. Its condition will be described in a subsequent section.

The body, electrical equipment and the vestibules were removed from former streetcar Number 7 during 1929. A large steel tank, in addition to a wooden deck, was mounted onto the frame. The tank was probably a surplus item from the Cromdale car barns boiler replacement of 1925. (SRDAR, 1925, p. 4) A pump, which had been salvaged from one of the sprinkler cars, was also installed on the deck. Through a system of pipes, the pump pressurized the contents of the tank. Three perforated pipes were installed on the unit so that they hung over one end of the frame. The purpose of this unit was to spray a toxic liquid over the area of unpaved tracks in order to reduce weed growth. Warning lights were mounted beneath the frame to warn individuals of the hazardous spray. (See Plate 29) The "weed killer car" was unpowered and had to be pulled by some other unit of rolling stock. The hand brake was left intact, however, but the brake handle was replaced by a horizontally-mounted wheel. Electric power for the pump and the warning lights was provided by an electrical cable which was connected to the weed killer car at one end and to the towing vehicle at the other end. Plate 29 (City of Edmonton Archives) shows the weed killer car being pulled by the ERR built sweeper sometime during the early 1930's. The tank, pump, pipes and lights should all be noted.

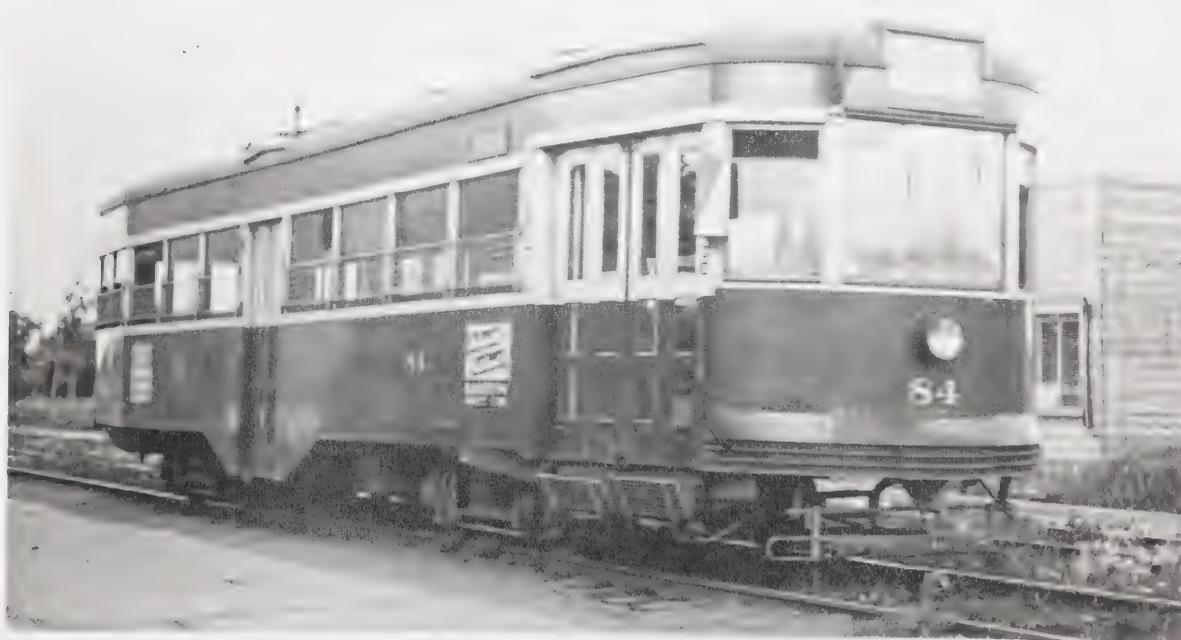
Plate 31. (Author's Collection) Streetcar Number 84

The streetcars were painted in the red and ivory paint scheme described previously. There were two modifications, however. The letterboards were painted red instead of ivory. The number at the ends of the streetcar could not be placed on the letterboards because of the roller signs. The numbers, in gold, were centred on the dashes below the centre windows at each end. (See Plate 31) The streetcars were numbered 80 through 84.

position, a whistle was mounted on the letterboard to the right of the front roller sign. (See Plate 31) An additional whistle was placed at the rear of the streetcar beneath the floor. This whistle was operated by the motorman and was used to warn pedestrians and motorists when the streetcar travelled in reverse. (Ottawa Car Manufacturing Co. Specifications, p. 13, and Drawing of Piping Layout)

During this period, the Ohio Brass headlights were removed from streetcars 80 through 84 and were replaced by the standard Crouse-Hinds type Z headlight. In addition, the route colors were painted on the back of the motorman's mirror. This did not pose a problem for route changes since these streetcars were continually assigned to the same route. It is probable that the route colors were placed on the mirror because the colored roller signs could not be seen easily during the day. (See Plate 31)
